TECHNICAL MEMORANDUM  
CSS TM 607-92

SEPTEMBER 1992

MK 15 FULL FACE MASK INHALATION  
VALVE RETAINER TESTS

T. A. BARTH

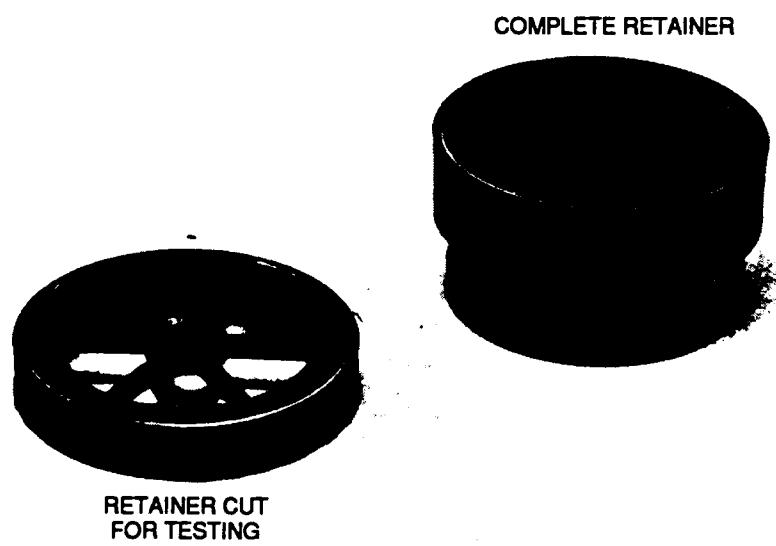
**FIGURE 5. RETAINER CUT TO FACILITATE TESTING**

For destructive testing, all the inhalation valve retainers used for test samples were cut apart approximately 5/16" from the spider end, thereby eliminating the inside undercut (Figure 5). This aided in designing the male testing jig and helped in the testing itself. The sample fit into the female testing jig as shown in Figure 6, and seated on a ridge so that no part of the spider was supported.

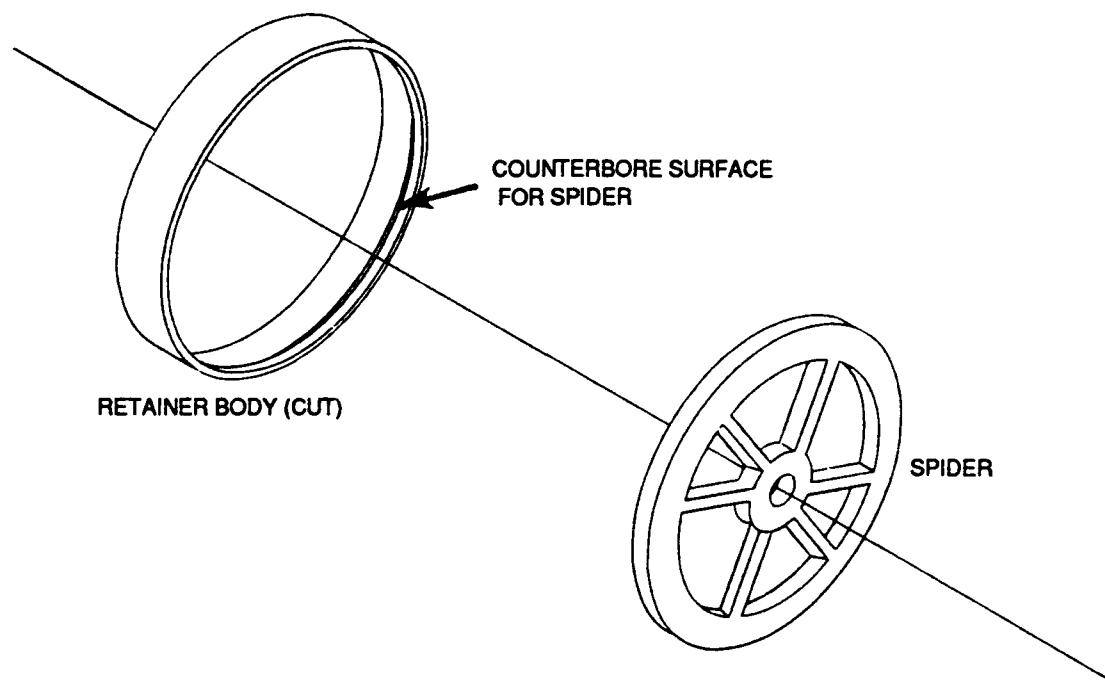
**FIGURE 8A. NEW INHALATION VALVE RETAINER**

**Results of Visual Inspection.** A visual inspection of each failed piece was also performed. In all cases of the new valve retainer samples, failure occurred at the adhesive bond line between the spider and retainer body. In no case did failure of the plastic occur. There was little evidence that the adhesive actually sheared apart; failure occurred because the adhesive separated from the plastic bonded surface. The Biomarine retainer failed when the plastic fractured (see Discussion).

The smallest load at which failure of the new retainers occurred was 155 pounds. The area of the bonded section was calculated to be 0.47 square inches ( $\text{in.}^2$ ), indicating a shear stress of 329.8 pounds per square inch (psi) in the adhesive at failure.

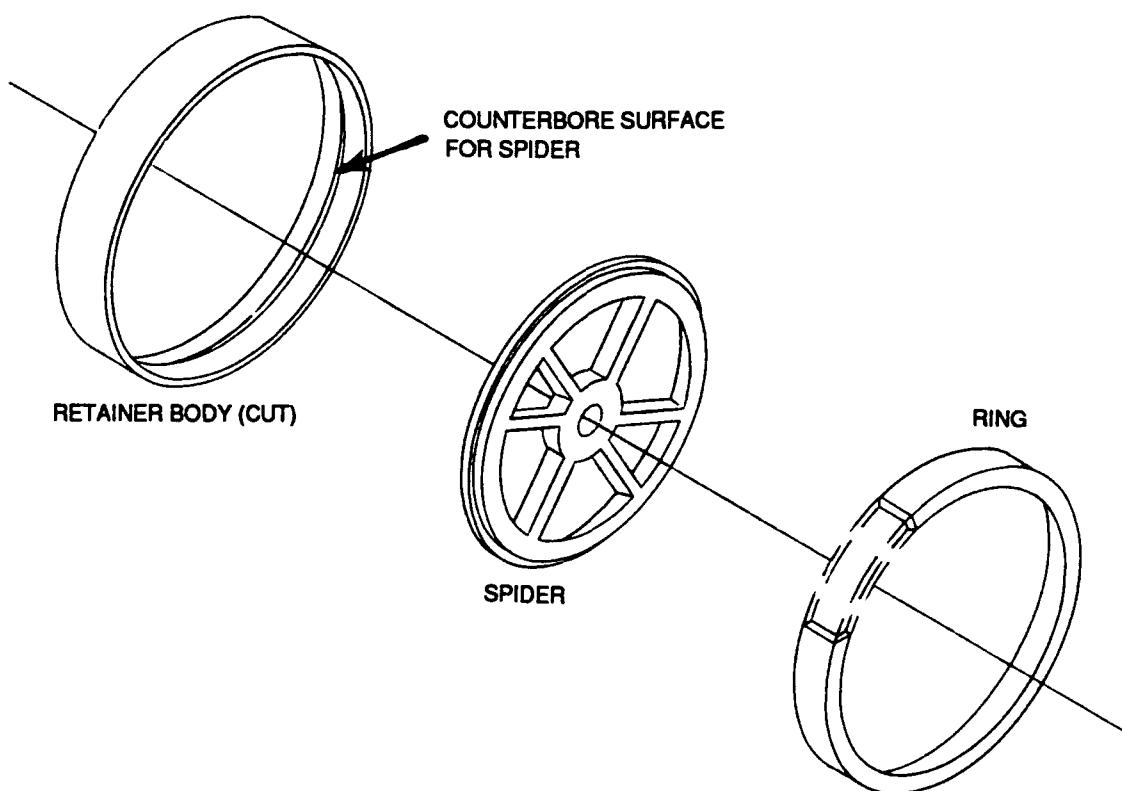
**FIGURE 8B. BIOMARINE INHALATION VALVE RETAINER**

Failure comparison to the Biomarine valve. The Biomarine inhalation valve retainer failed at 780 pounds, more than twice the force required to break the strongest new retainer. Closer inspection of this failed piece revealed that the two retainers were assembled differently. The new retainer (Figure 8A) consists of a 0.095-inch thick, 1.58-inch outside diameter (OD) spider that fits into the retainer body and seats on a very small ridge. The bonding area consists of the entire circumference of the spider, plus a small bonding area between the ridge and spider, nominally 0.471  $\text{in.}^2$ .

The Biomarine retainer was built in a more complex process that resulted in three pieces (Figure 8B). The spider consists of a 1.487-inch OD, 0.10-inch total thickness piece; however, 0.054 inches from the top of the spider, the diameter was shaved to 1.400 inches, creating a "small" piece atop a "larger" piece. This spider was then bonded inside a piece with a 1.585-inch OD and a 1.400-inch ID (ring). The ring has a lip around it that is 0.049 inches wide and 0.198 inches long. In effect, the ring seats on the larger diameter of the spider, with the lip of the ring surrounding the spider and extending 0.098 inches beyond the thickness of the spider. The lip part of the ring was then bonded into the retainer.

The effective area of bonding of the spider and ring is nominally 0.980 in.<sup>2</sup>, approximately twice the bonding area of the new configuration. The test loading performed on the Biomarine piece pushed against the ring instead of the spider.

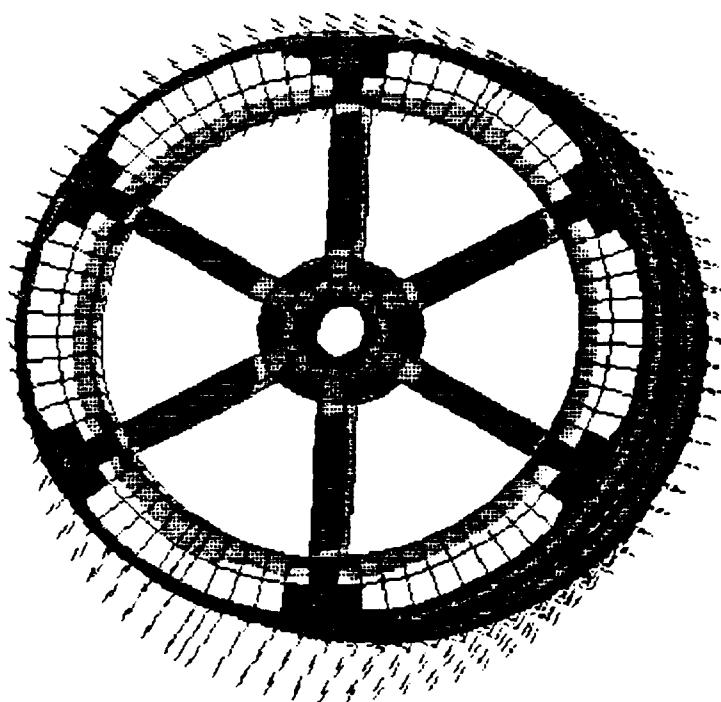
INHALATION NONRETURN VALVE RETAINER

2. The area of interest exists at the retainer face/ glue interface. With a 10 pound load exerted on the edge of the retainer face, the stress at the interface is approximately 150 psi. Under the same conditions, a 5 pound load resulted in 75 psi stress at the interface.

5 pounds exerted on perimeter of retainer face  
von Mises stress in units of psi

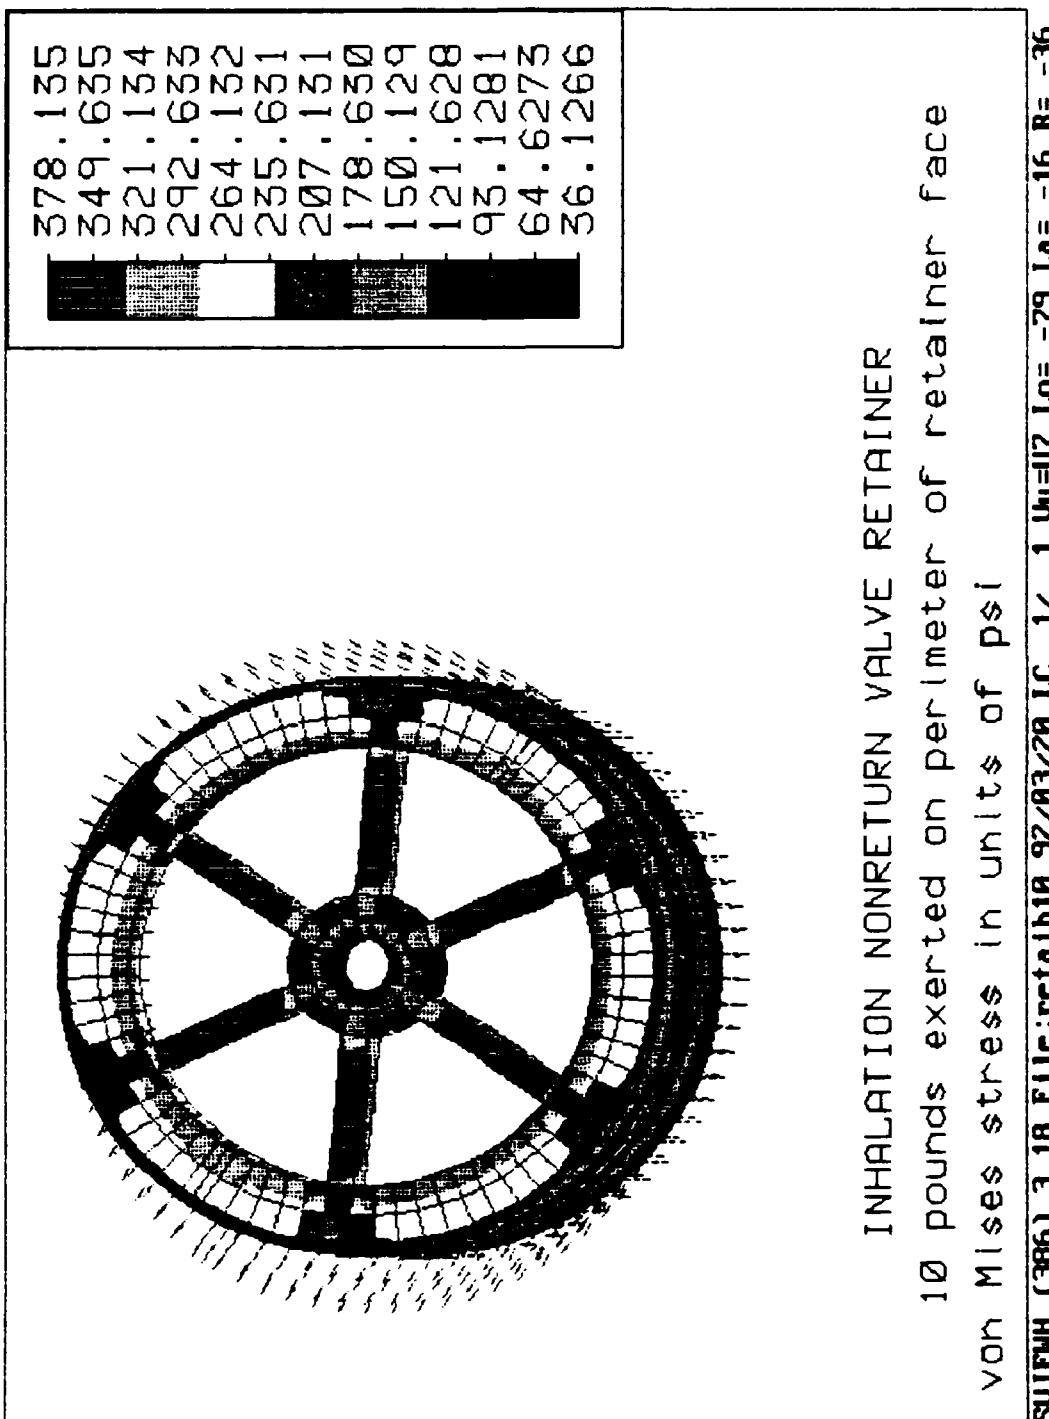
which encompass both shear and tensile stresses in the model. Observations made based on these stress estimates indicated that the adhesive would fail at circumferential loads of between 60 and 80 pounds (lbs).
